Introduction and methodology (Freiha pottery report)

Qatar Islamic Archaeology and Heritage Project

End of Season Report

2013 - 2014

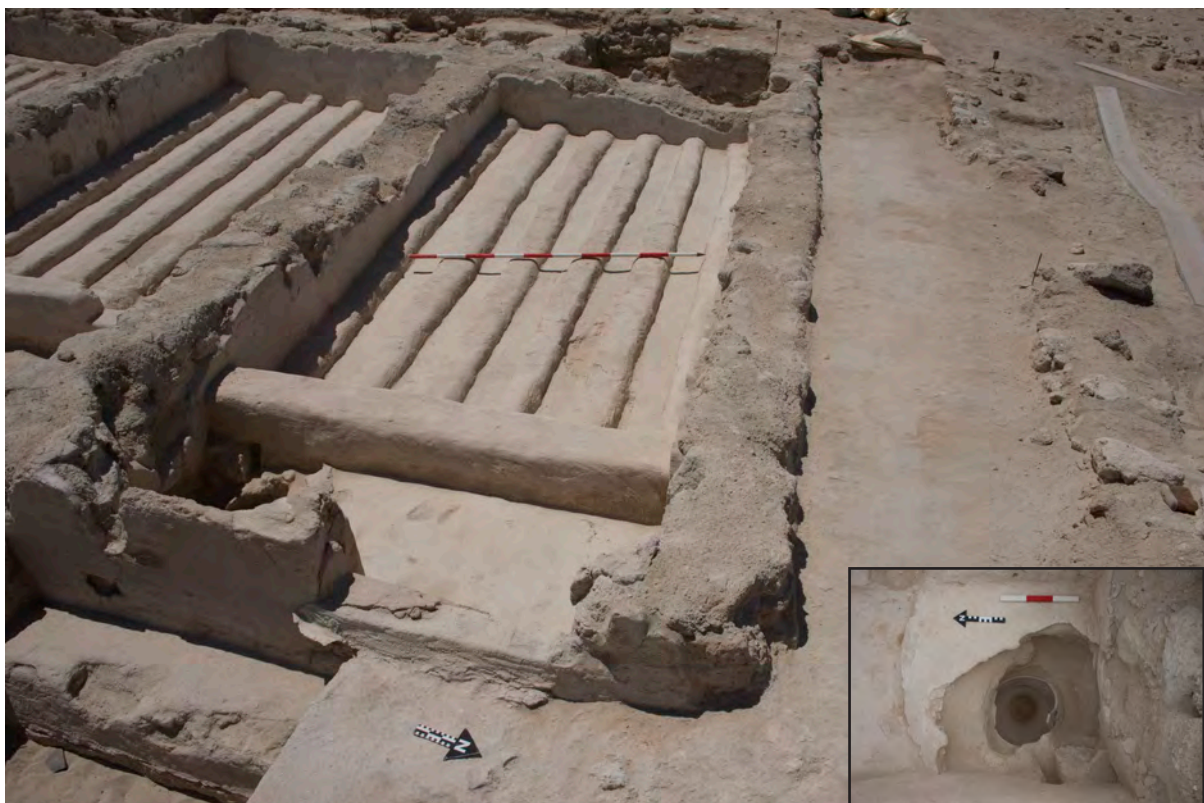
Figure 2.3: Date press Space 71, looking west. (KF-0541) The inset shows a detailed view of the date syrup catchment vessel *in situ*. (KF-0426)

Of particular interest in Space 71 were the changes evident in the structure's façade, with the original ingress being a wide opening spanning the entire frontage with two plastered, curved columns either side. This appears to be reflecting an earlier function of the room prior to the conversion to a date processing structure, possibly as an open shop frontage together with adjacent rooms. Surfaces can clearly be seen within the catchment pit here and in other rooms, predating most of the date presses.

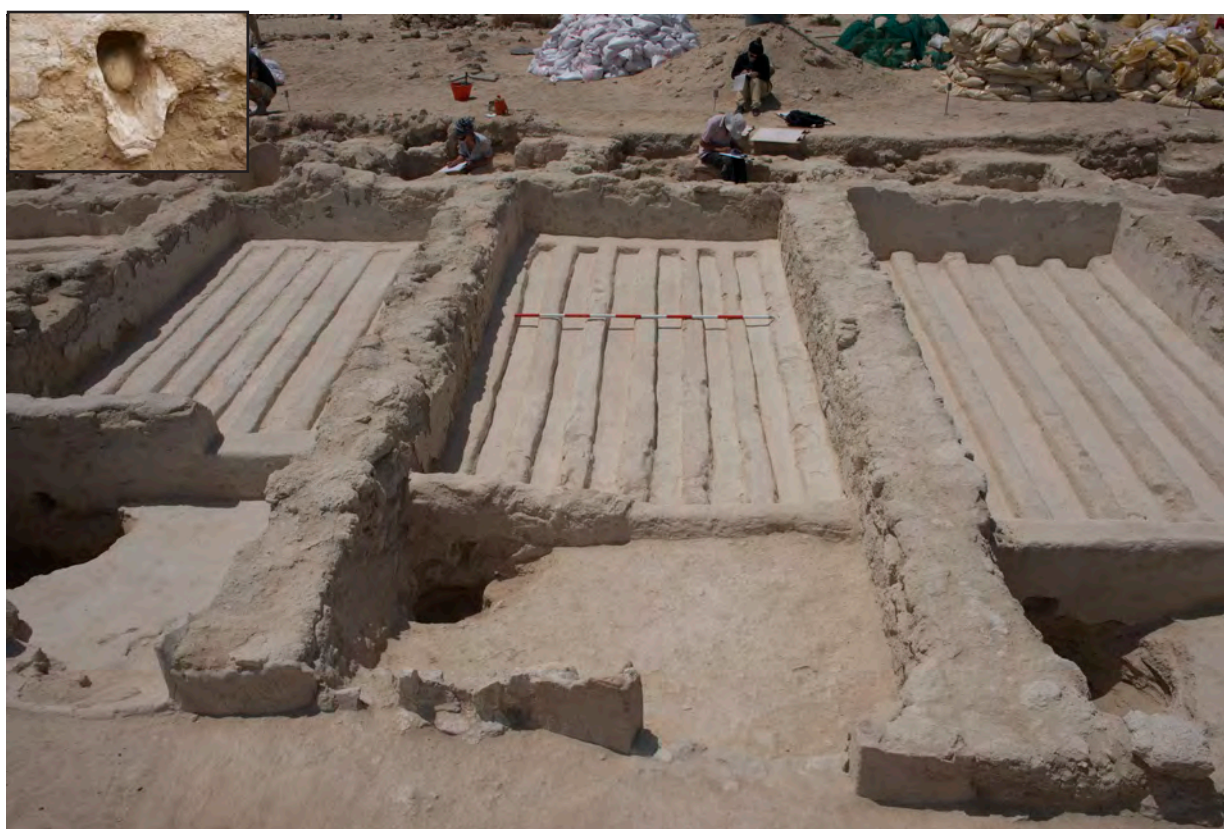
Figure 2.4: Overview of date press Spaces 76, 75 and 74 (left to right), looking west. (KF-0766) Inset shows the stopper *in situ* within the channel. (BE-0573)

These three date presses, of similar dimensions as Space 71, are aligned E-W and accessed from the main street (Space 602). They show slight variations in the size and depth of internal features such as the kerb wall (which in Spaces 75 and 76 had a small, shallow threshold) and the length, depth and profile of the date press superstructure. The gypsum plaster in all the rooms varied in both colour and consistency; in Spaces 75 and 76, the plaster was particularly weak and crumbled on touch, and repairs were evident on the walls in both rooms. In Spaces 71 and 74, the plaster was much more robust, and although repairs and adjustments had been made, they were less extensive. **All of the rooms had their catchment vessels removed prior to abandonment.** Interestingly, Space 76 had a rounded stone stopper placed within the channel between the date press and the catchment room (Figure 2.4), its function likely to halt the flow of date syrup whilst the collection vessel was being decanted. Several similar ball-shaped stones had been found within other date press rooms but their function, until this discovery, had been unclear.

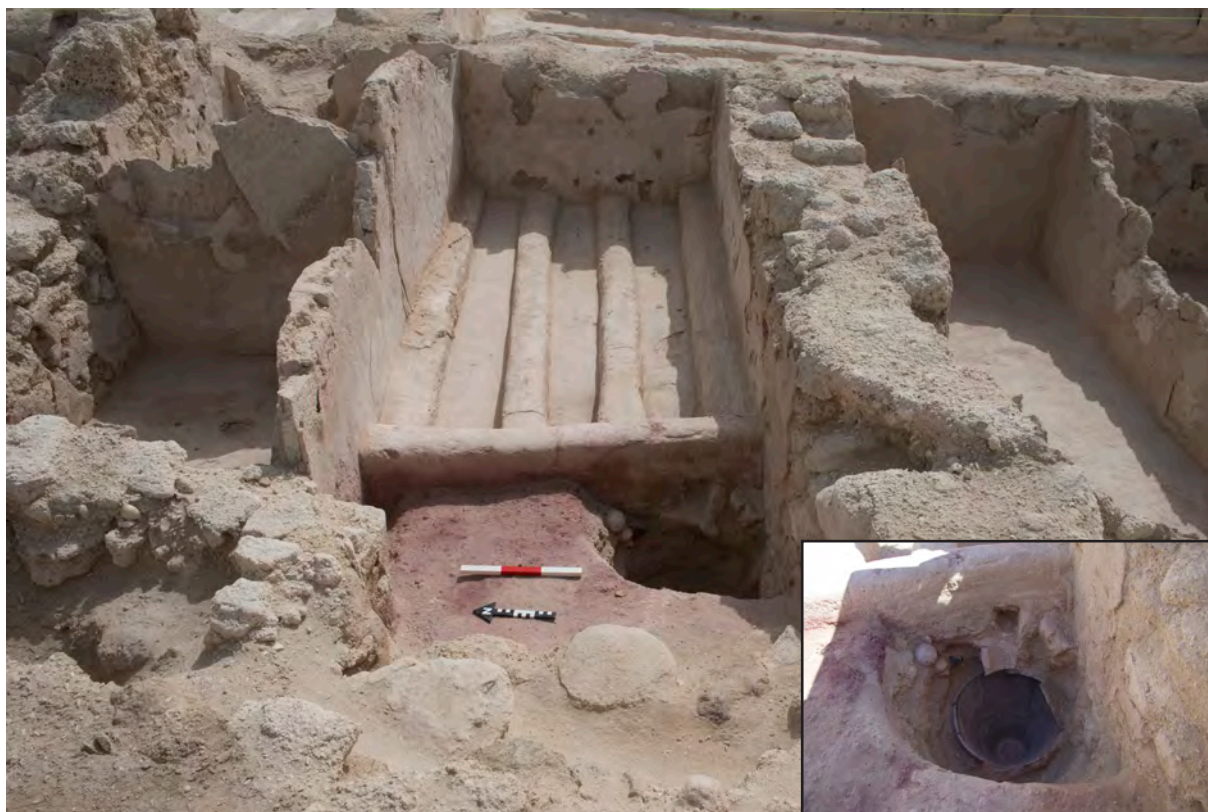
Figure 2.13: Post-excavation view, looking east, of date press Space 92, clearly showing the crushed haematite in the catchment room. (KF-606). The inset shows the *in situ* catchment pot and stone stoppers. (PF-0508)

Space 92, located to the south of Spaces 93 and 94, is a small plastered rectangular room (2.50m x 1.20m) which turned out to be a very small date press. This was an exact miniature of its large counterparts in the rest of the Northern Extension, even down to a small catchment room at its western end (Figure 2.13). The surface of the *madbasa* was strewn with ceramics and stained with a red powder as well as some fragments of the pigment itself, and mixed with the ceramics were another intact faience button, a single coin, some iron brackets or buckles, and a small spherical copper alloy earring or bell (Figure 2.14). A disturbed area against the northern wall of the space (possibly an animal burrow) contained a fine stone bead and a faience button, but these can likely be attributed to the usage phase of the room. The ceramic fragments of the catchment vessel were removed, including the fill of the *in situ* base and the partial body.

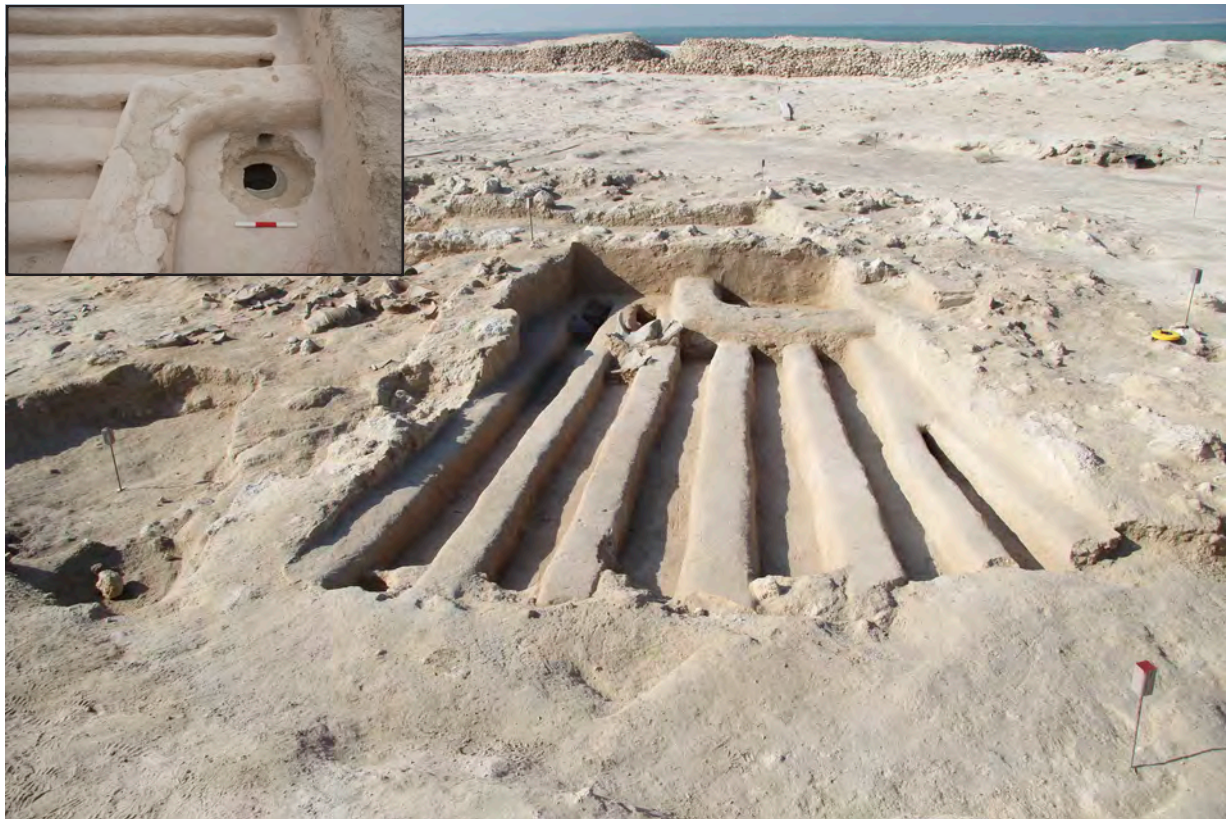
Figure 2.21: Looking west across the fan-shaped date press Space 88 and ceramic spread. (PE-0032). Inset is the *in situ* catchment vessel. (KF-0436)

Located to the east of Space 87 lies a large, sub-rectangular room 5.00m NE-SW x 2.10m – 3.50m wide (wider in the east). This space is architecturally spectacular, due mainly to the form of the room dictating the unique **fan shape of the date press**. This unique room also had a small space in the NW corner formed by a low kerb wall, the location for the catchment pot for the *dibs* which was present *in situ*. Above the plastered surface of the press was a large, broken ceramic storage vessel, which may well have been used in conjunction with the press (Figure 2.21).

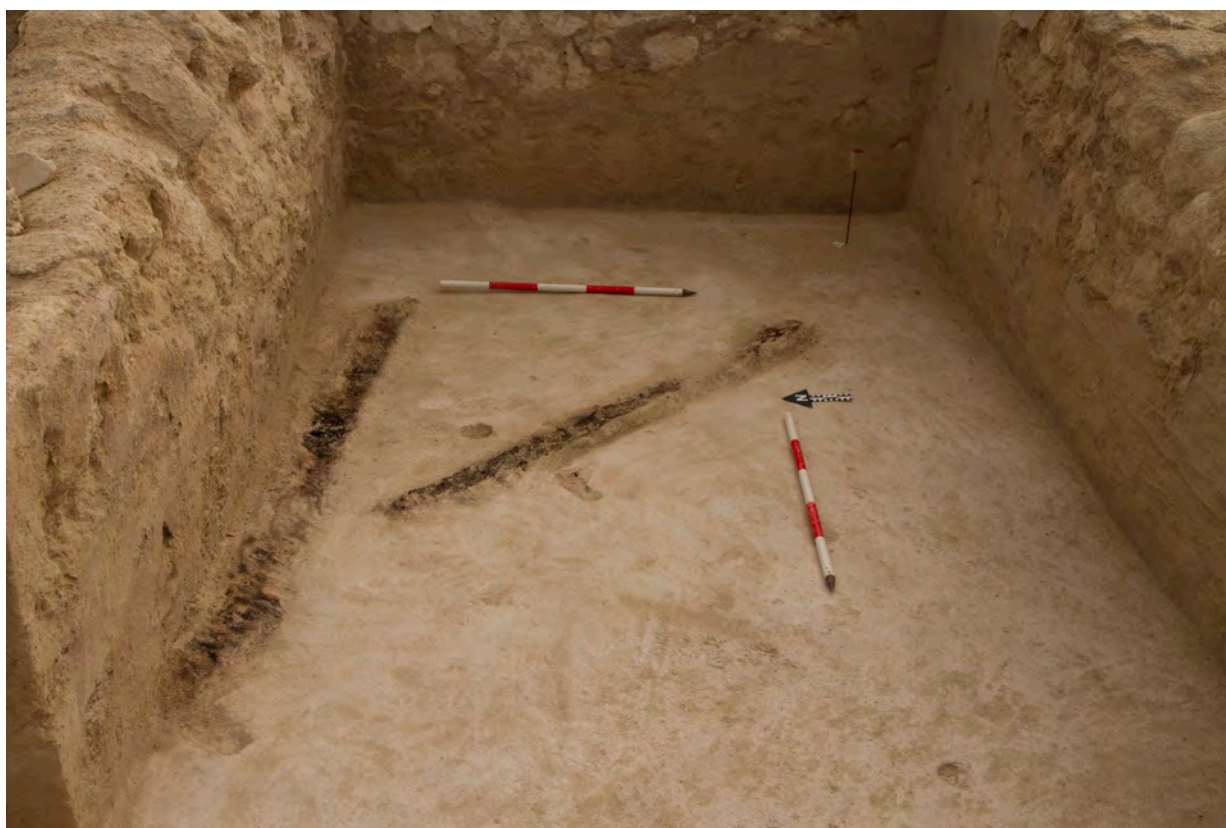
Figure 3.5: Collapsed ceiling beams at the eastern end of Space 3031. (HF-0771)

No occupation deposits were found in this room. Instead, large plastered architectural elements were discovered. In addition to the **collapsed arch** fragment left *in situ*, a large plastered door post element was found lying near to the doorway to Space 3035 in 2013. Underlying rubble collapse layers were then investigated, but these too were not fully excavated since the western ends were left *in situ* to support the arch remnants. Two large chunks of fallen plaster and masonry were found sandwiched between these two layers. They lay at the base of the southern wall and were presumed to be part of the higher wall surfaces that had fallen down fairly early in the buildings collapse. Most interestingly, the remains of collapsed ceiling beams were discovered lying directly above the plaster floor (Figure 3.5). These consisted of dark brown to black, organic, degraded wood and were superb evidence of the roof that once covered the space.

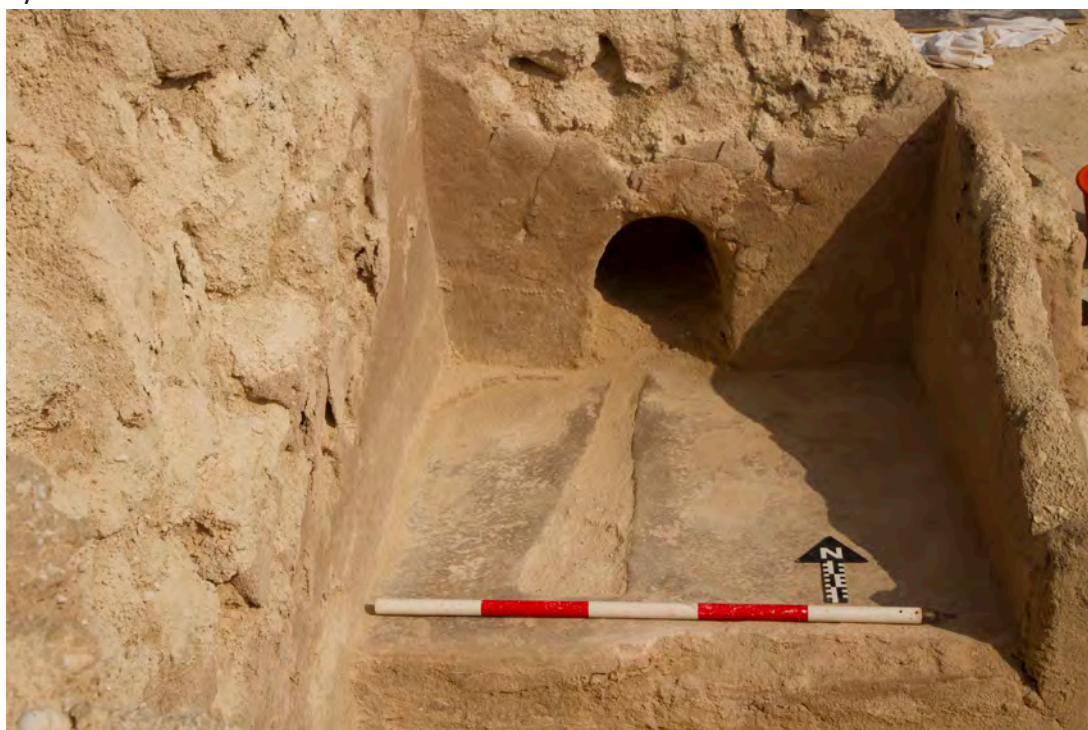
Figure 3.7: *Hammam* in Space 3035. (HF-1094)

The total excavation of Space 3035 revealed the extant remains of a *hammam* in the north-western corner. It was comprised of an elevated platform with a thin plastered stone wall in the east and the south. Entrance to the *hammam* came from the south. The platform base had a very shallow channel which sloped and tapered down from a wider end to a narrower lower end, which then ran into a cavity built into the northern wall (Figure 3.7). The *hammam* drained into a soakaway pit either in the southern side of courtyard Space 3039 or indeed into a pit directly under the wall.

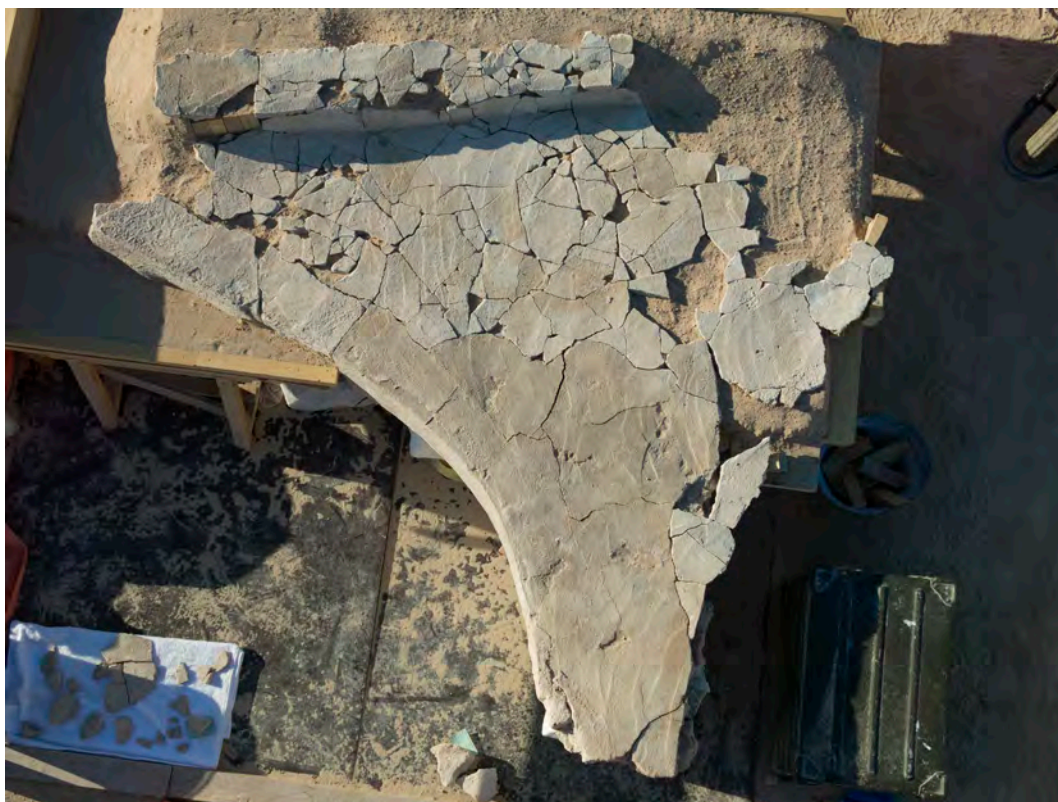
Figure 3.16: Front of arch 4859 showing the cornice. Compare drawing Figure 3.8. (WF-0395)

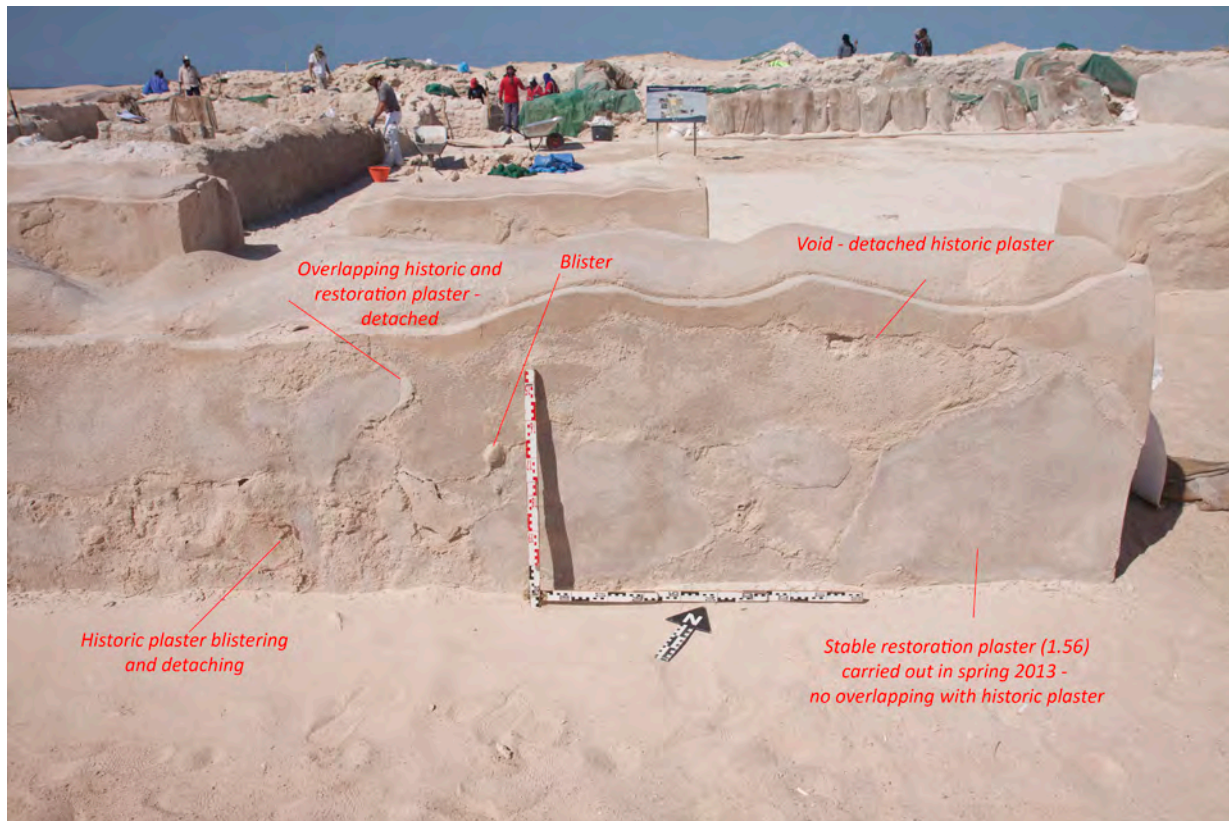
Figure 3.20: Wall 4090 in Space 3003, showing damage patterns on the plaster surface. (DE-0560)

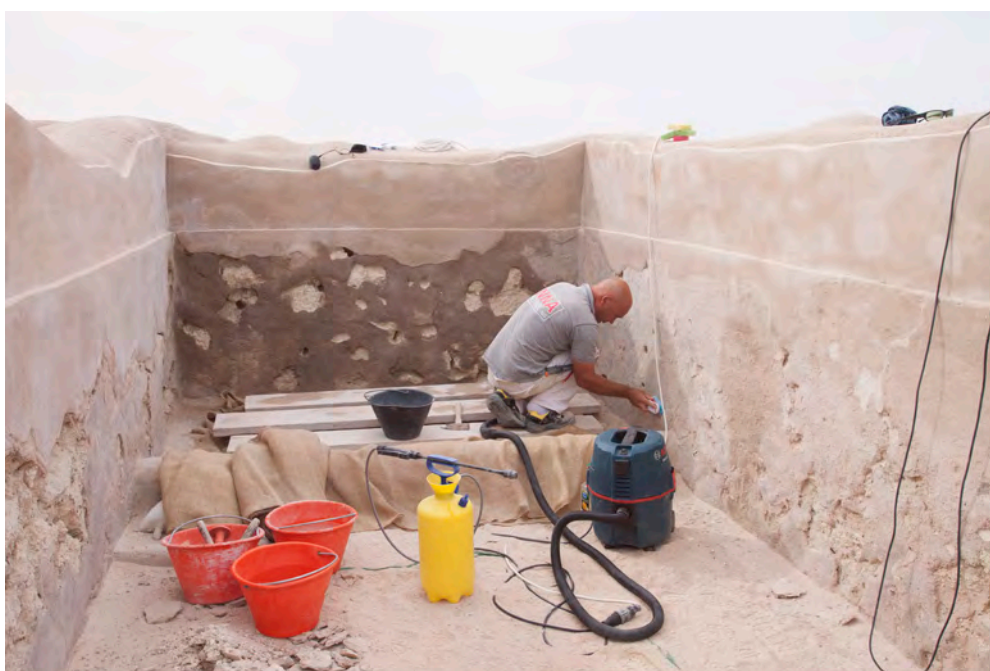
Figure 3.22: Preparation of walls in Space 3005 for void repair. Detached plaster were removed. (DF-0378)

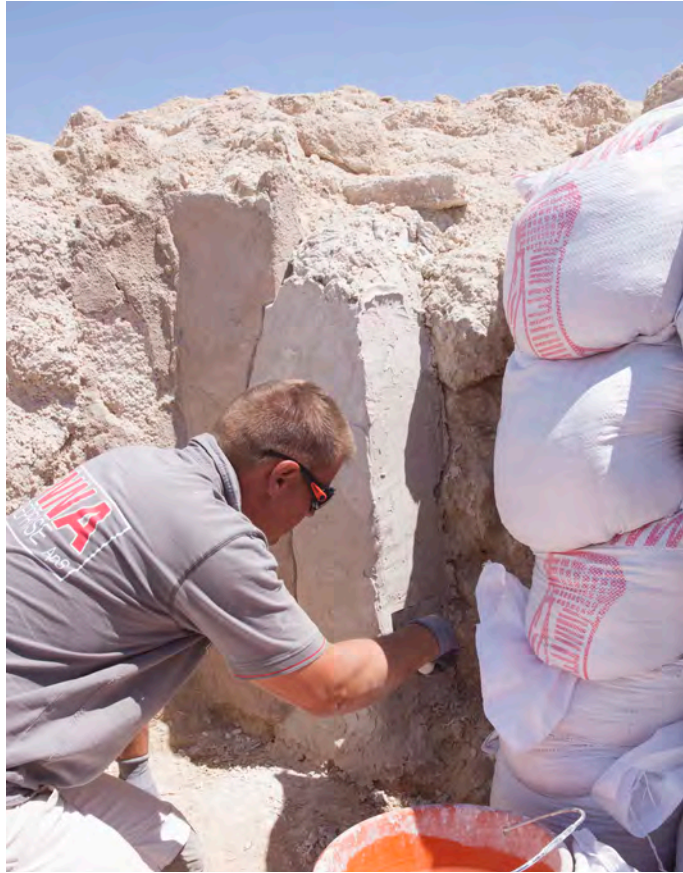
Figure 3.23: Reconstructing the plaster surface on the door jamb, scratching the surface with a knife. (DF-1085)

Findings on the walls in Spaces 3020, 3026 and 3027 proved that the walls of open spaces such as courtyards and corridors were plastered with soil/clay mortars. Only door and window jambs,

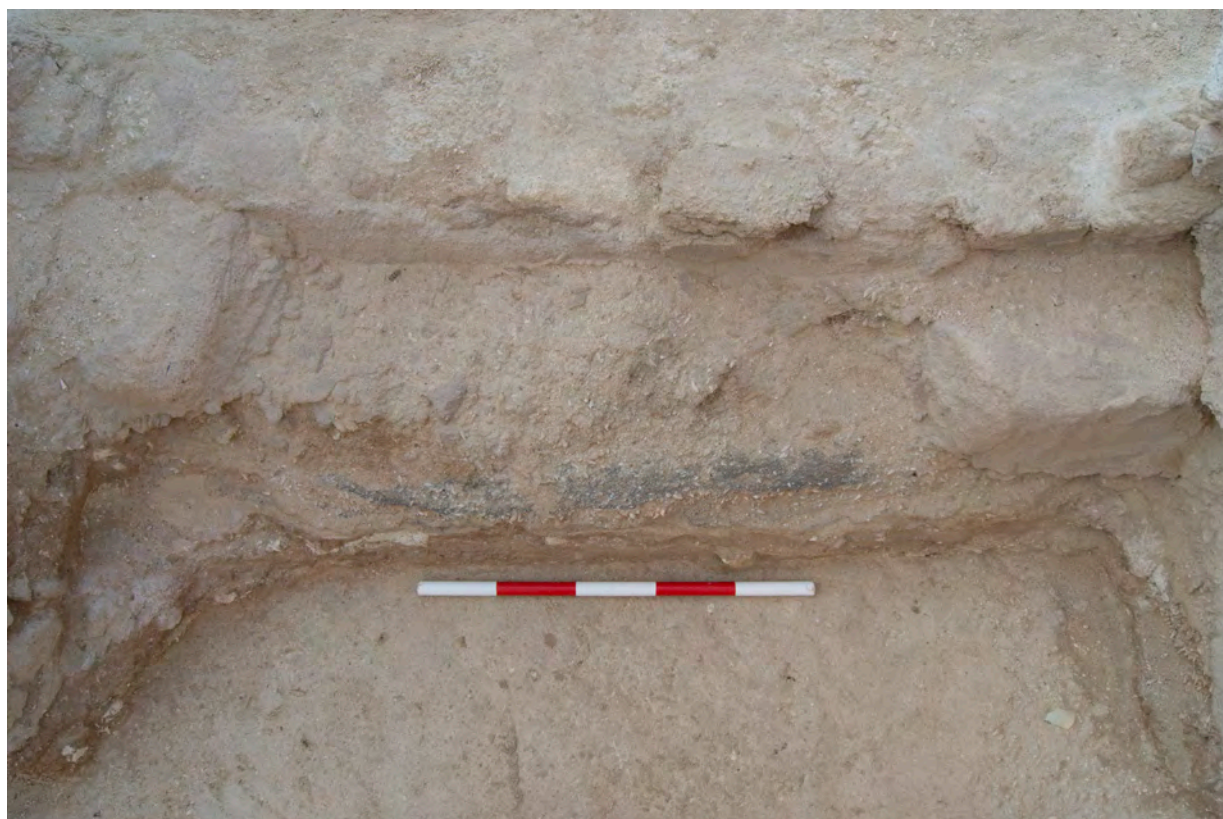
Figure 4.4: Entrance-way into Space 10008 with added door sockets. (YF-0043)

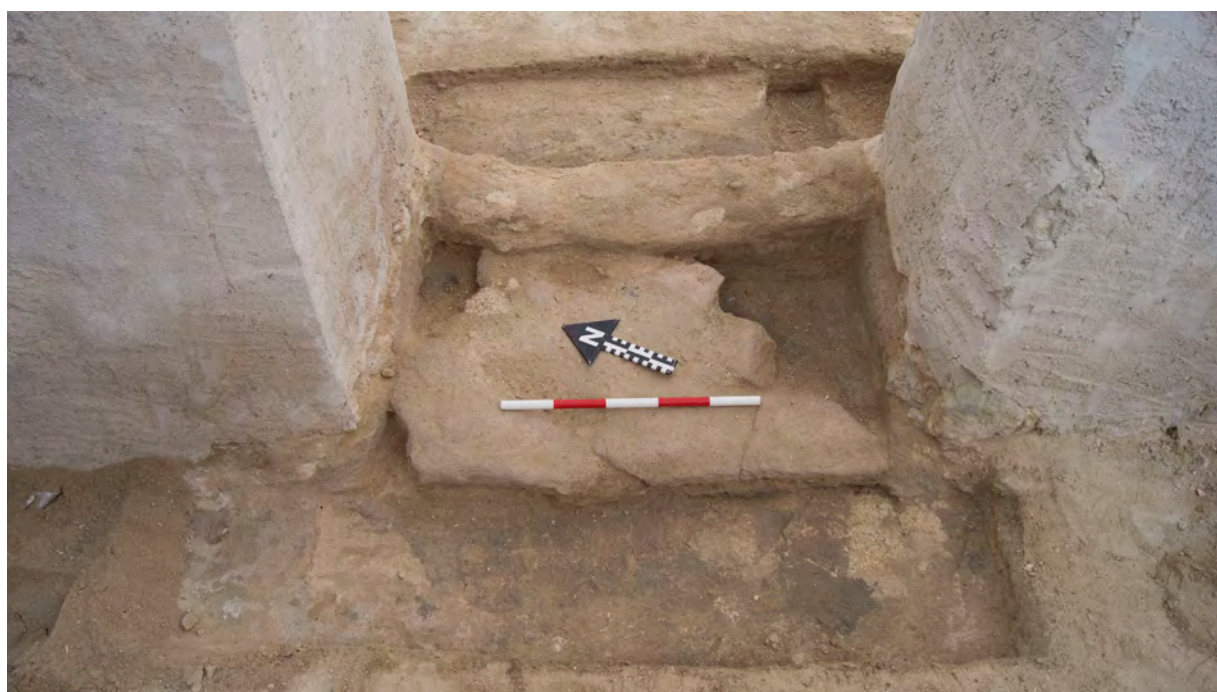
Figure 4.5: Doorway between Spaces 10010 and 10011. (XF-0685)

The sondages also helped to define more clearly the nature of the thresholds to Space 10011 (Figure 4.5) and Space 10013.

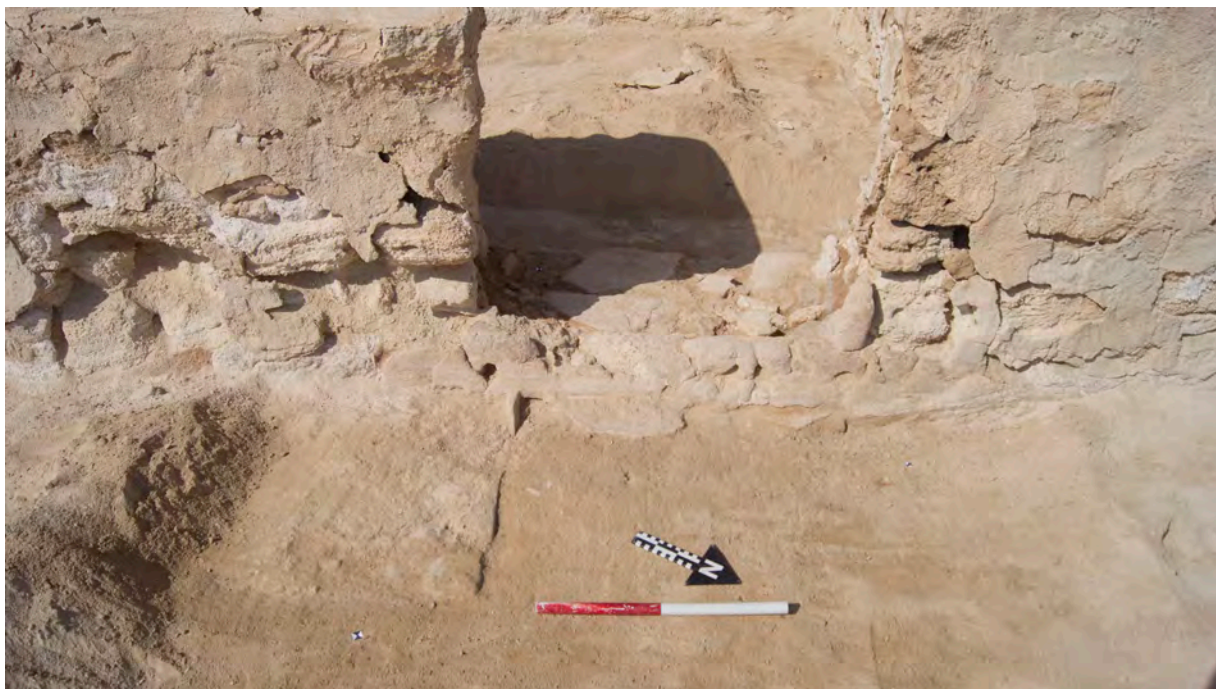
Figure 4.6: Badly preserved threshold between Spaces 10001 and 10003. (XF-0661)

This sondage investigated the doorway between Spaces 10001 and 10003. A possible platform could be identified here as in the other courtyard spaces. The doorway's threshold was only partly preserved (Figure 4.6).

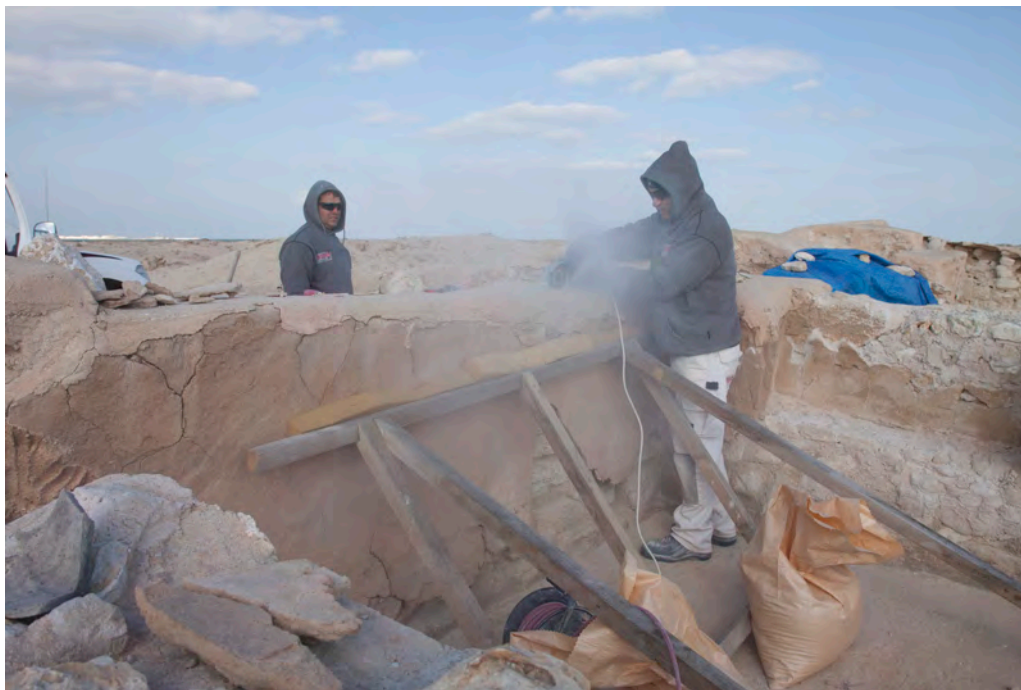
Figure 4.10: Removal of the cement capping on a wall in Space 10006. (DF-0075)

The aim of the conservation work was initially to stabilise the architecture without removing the cement cappings and plasters where possible. It became apparent that while the cement

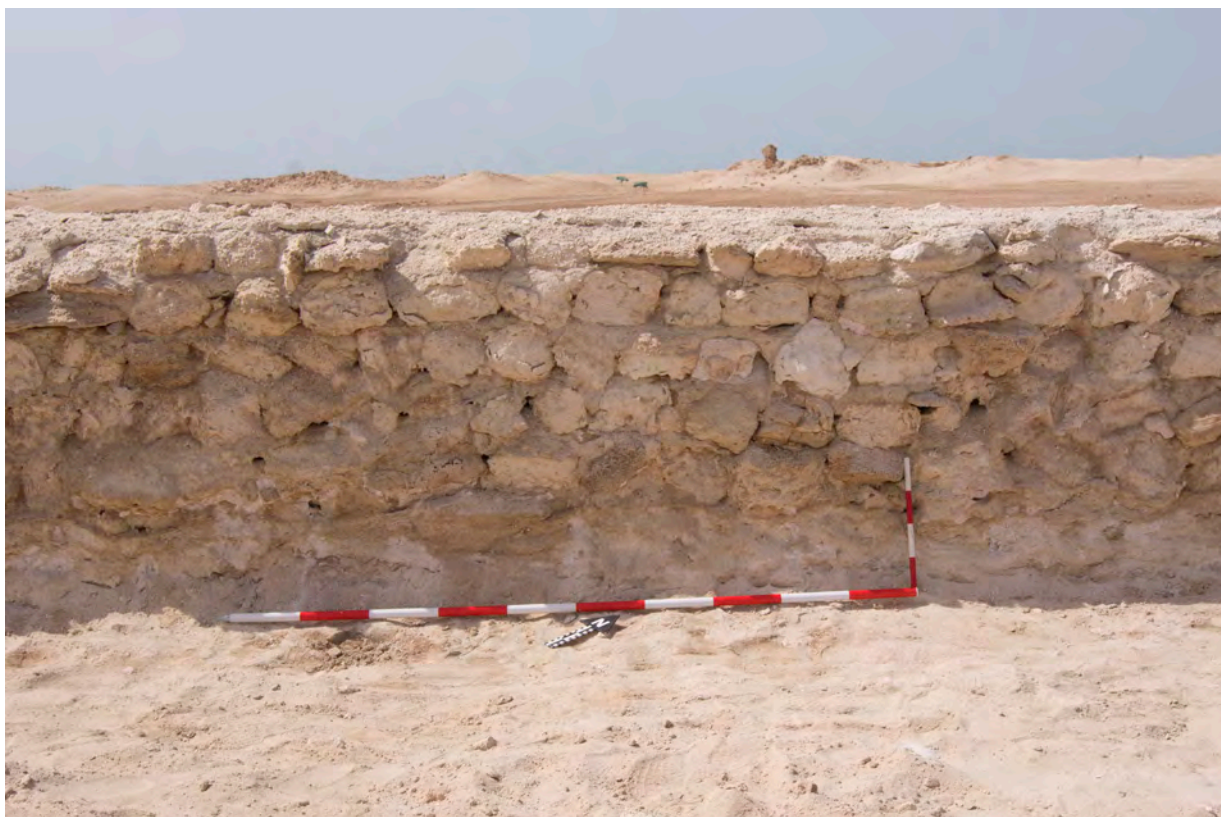
Figure 5.4: Condition of the outer shell of the Outer Town Wall before conservation. The brittle beachstone is extremely eroded. Hard cement mortar can be seen in horizontal layers. (YE-0229)

All town wall sections in ZUEP13 were found to be in very poor condition (Figure 5.4). Only poor quality beachstone and cement mortar were used for conservation of the town walls in the 1980s. In front of the preserved historic wall a completely new shell of about 30-50cm depth was reconstructed on top of one or two courses of historic stones. The cement mortar was laid solely in the horizontal; vertical joints were not properly filled with mortar. After being exposed for 30 years, the masonry of the reconstructed wall shell was strongly eroded, and spacious, deep gaps reached inside of the masonry. The top layer of stones was covered with thin, flat cement coating. Even gentle cleaning with brushes caused the stone material to crumble away from the wall face, so the cement capping could be easily removed from the top of the wall.

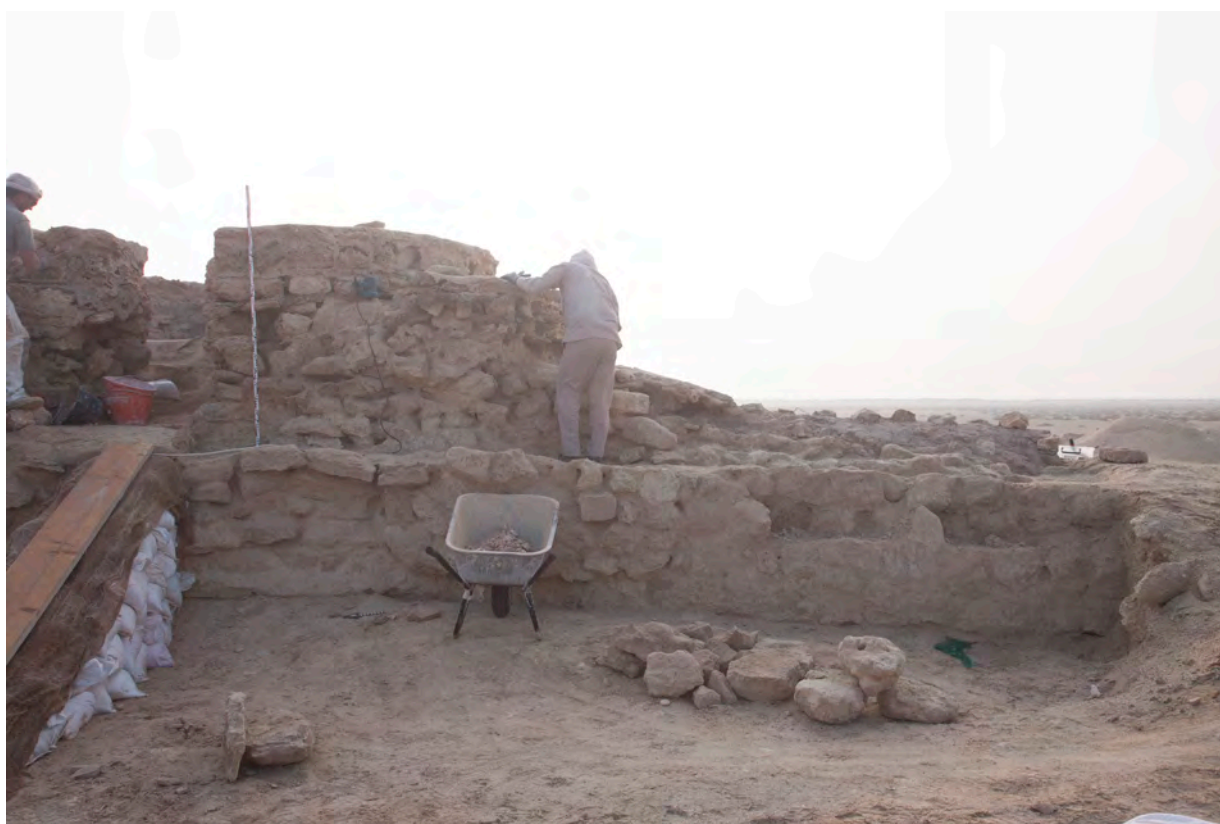
Figure 5.6: Walkway in front of T18 before consolidation. A blocking is seen behind the wheelbarrow. (DE-1339)

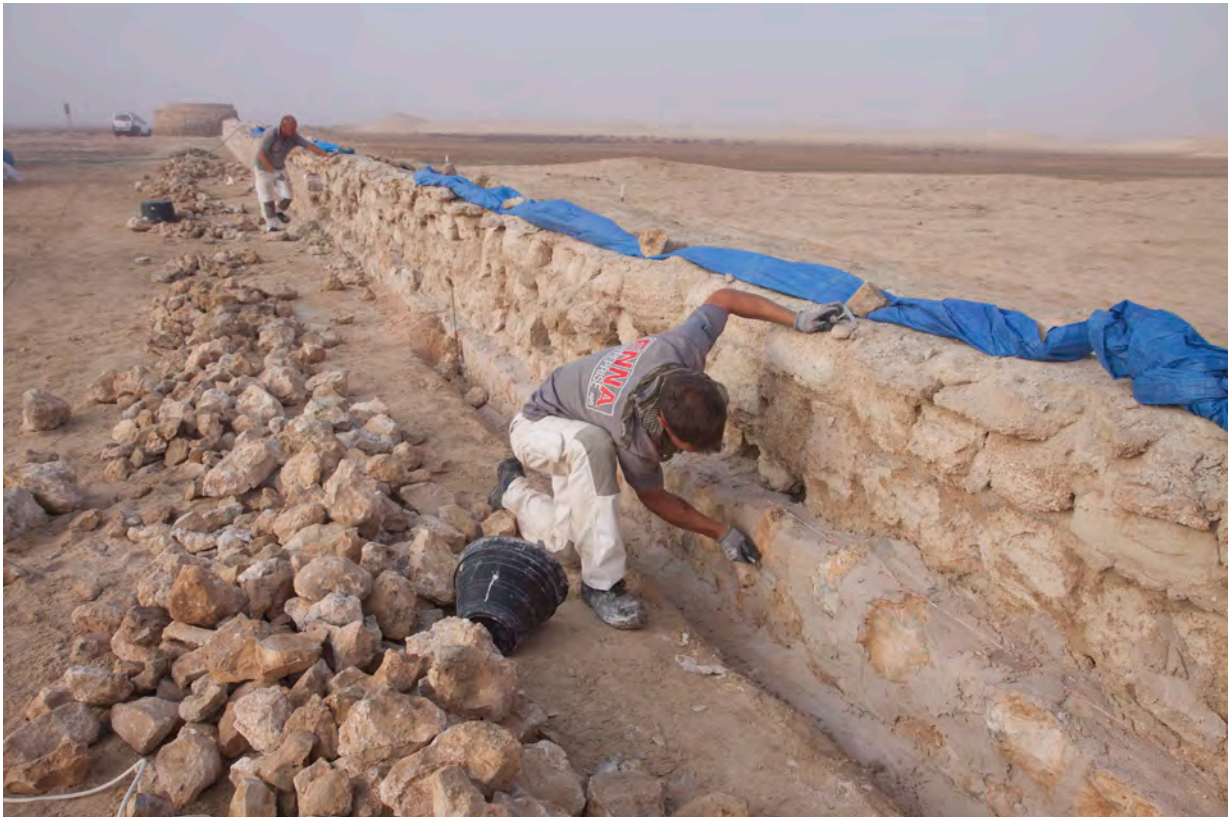
Figure 5.7: The new shell of the Outer Town Wall being constructed in front of the 1980s shell. (DE-0640)

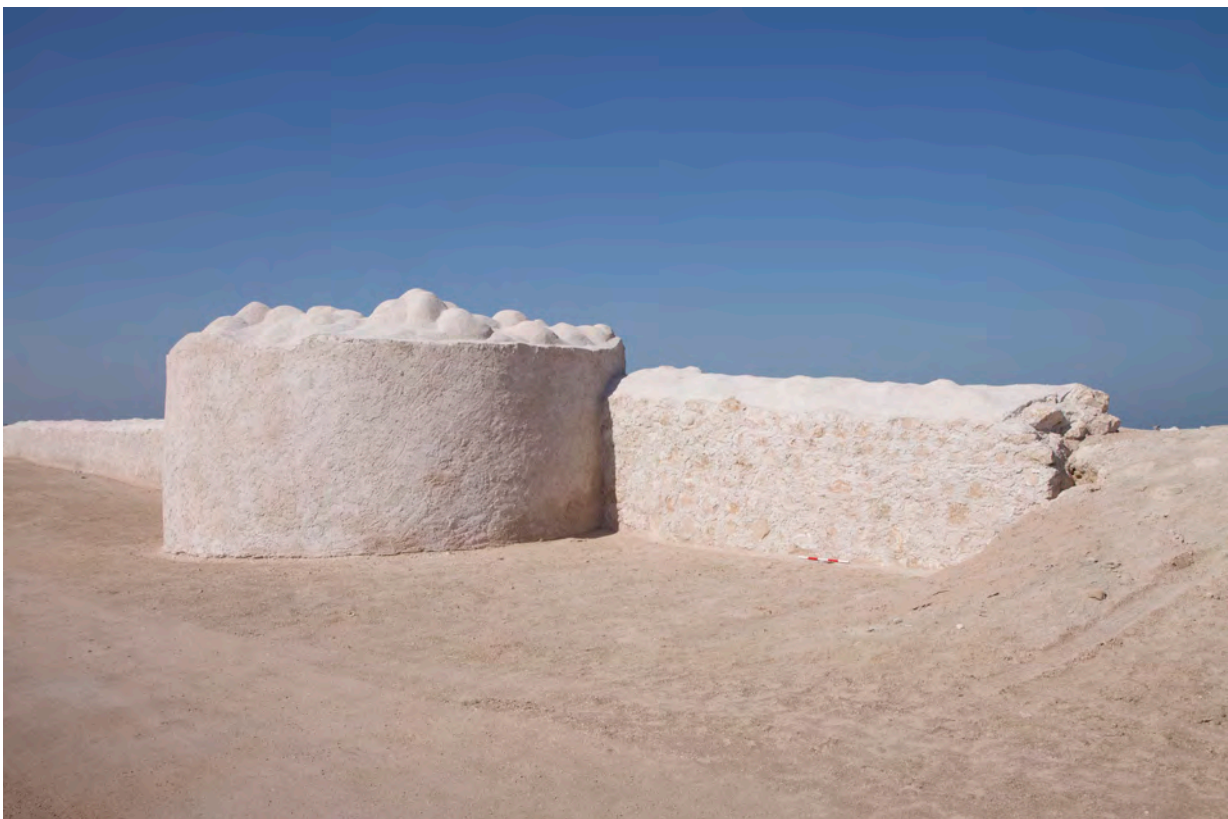
Figure 5.8: T16 after finished consolidation. The rough capping allows better drainage (DF-1076)

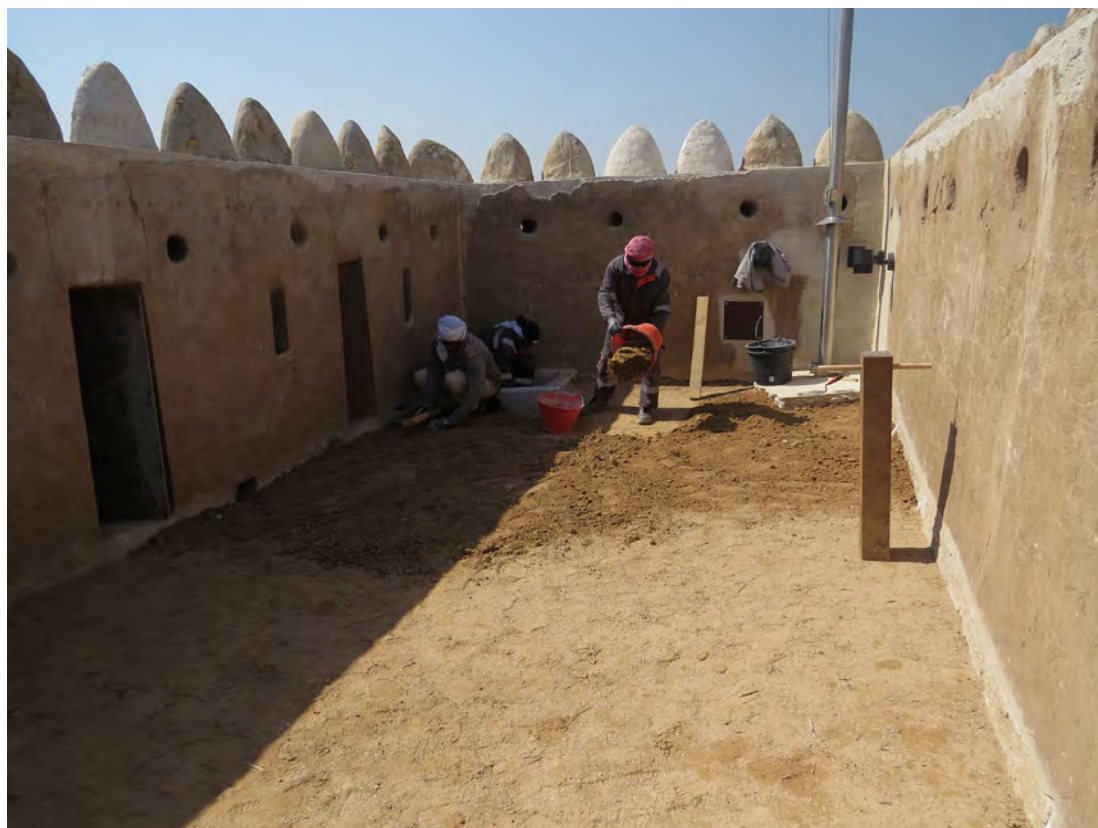
Figure 6.5: Earthen roof on the rectangular tower renewed with traditional techniques. (ZUTF-0568)

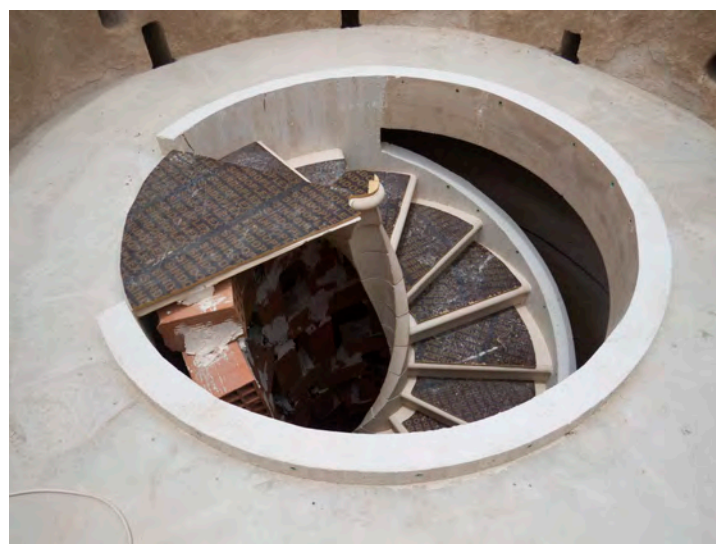
Figure 6.6: Staircase in the north-western tower under construction. (ZUTF-2048)

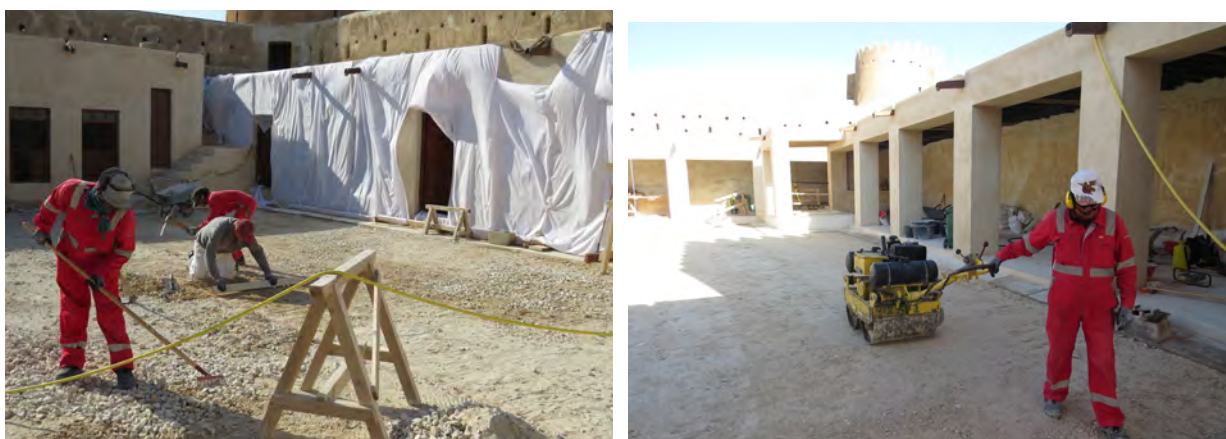
Figure 6.7: Applying the two layers of the new courtyard surface. (ZUTE-0327 and ZUTE-0356)

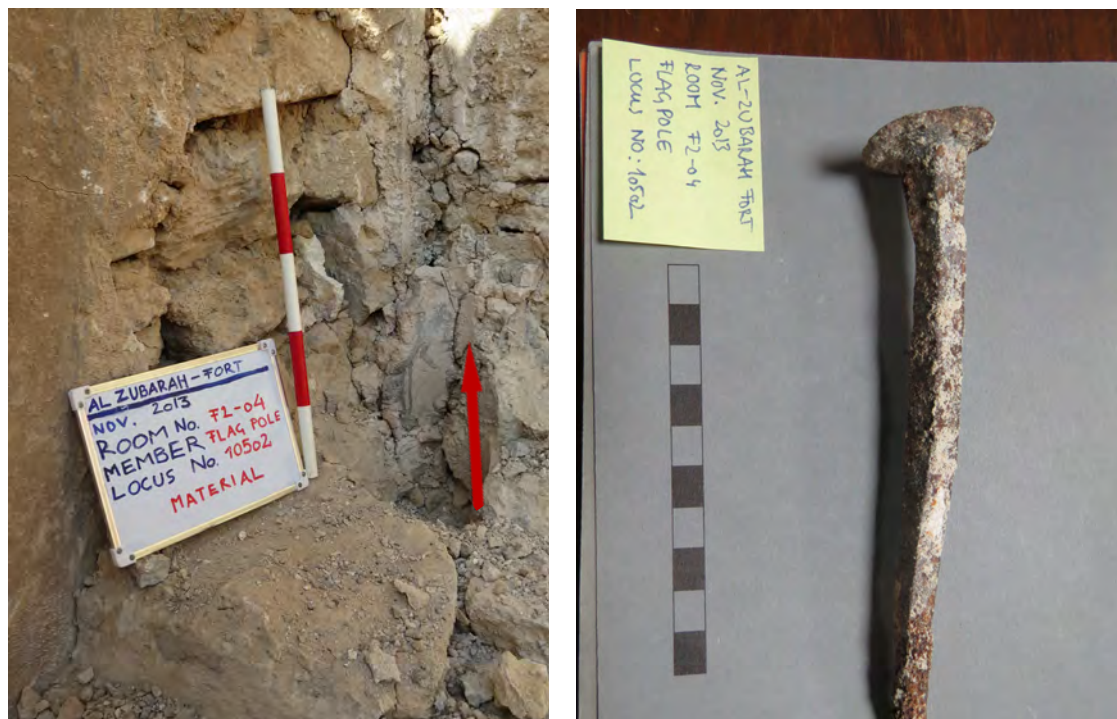
Figure 6.9: Left (ZUTE-0061): Masonry block for the flag pole during its demolition. The cement-based plaster shows a circular void with the impression of the texture of a wooden trunk (arrow). Right (ZUTE-0084): Hand-forged nail found in the masonry of the flag pole base. Similar nails were found in the dhow mast.

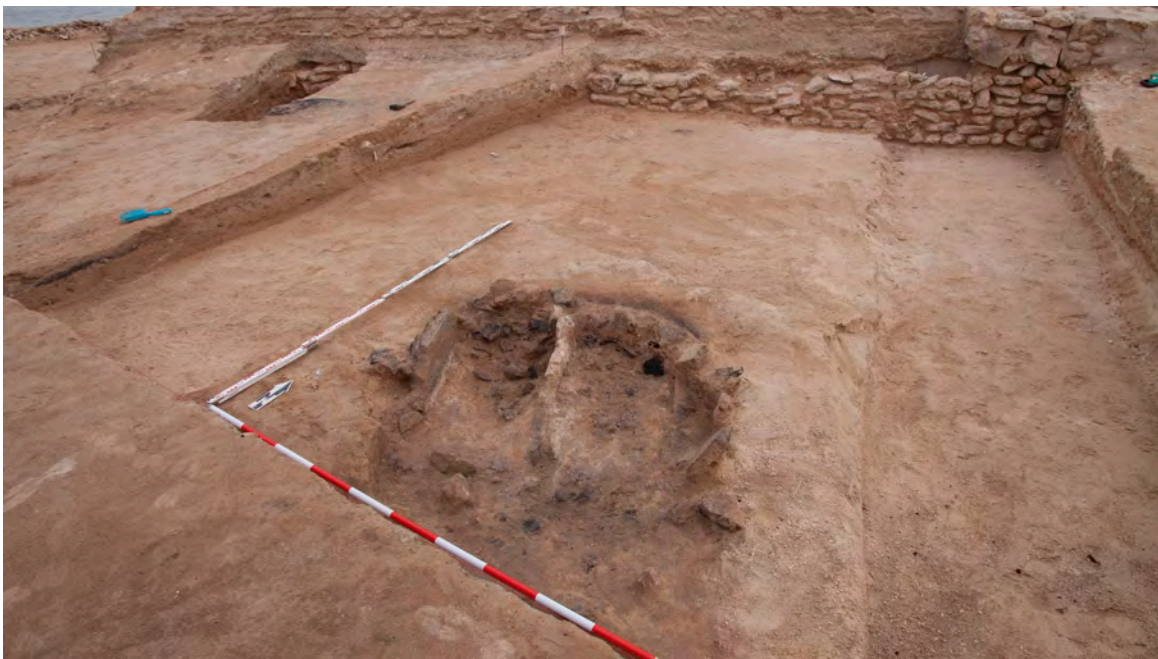
Figure 7.10: Double-chambered oven after excavation of the collapse. (CF-0276)

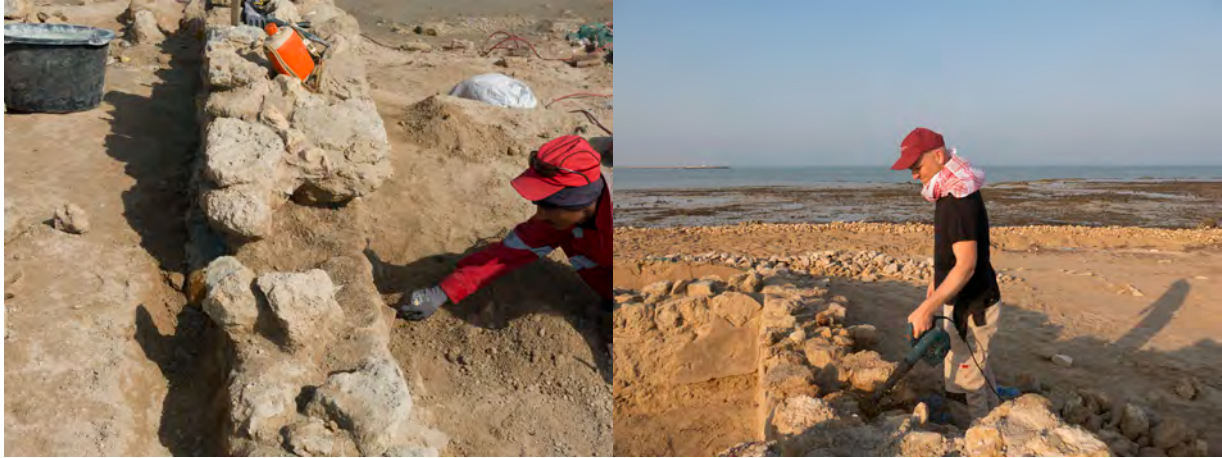
Figure 7.14: Dust, dirt and loose stones and mortar were removed with trowel and hand brush; eroded joints were scraped and cleaned with a blower before being repointed. (WE-0013 & WE-0040)
